# Solving Structural Degradation and Reducing Financial Risk in Masonry via Nano-Silane Based Polymer Nanocoatings

**Masonry protection using nano-silane based polymers can minimize aging effects and produce huge savings for individual home owners, public buildings and campus properties**

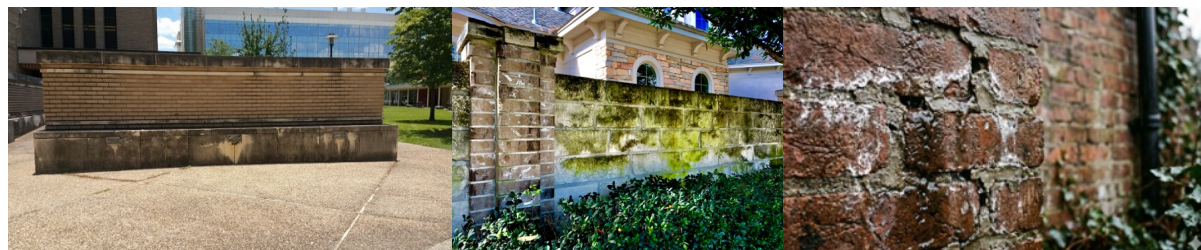
**Figure 2:** Damaged walls of different brick types that show efflorescence, mold, mildew, and water damage through delamination and loss of concrete.  
Photo credit S. Curran.

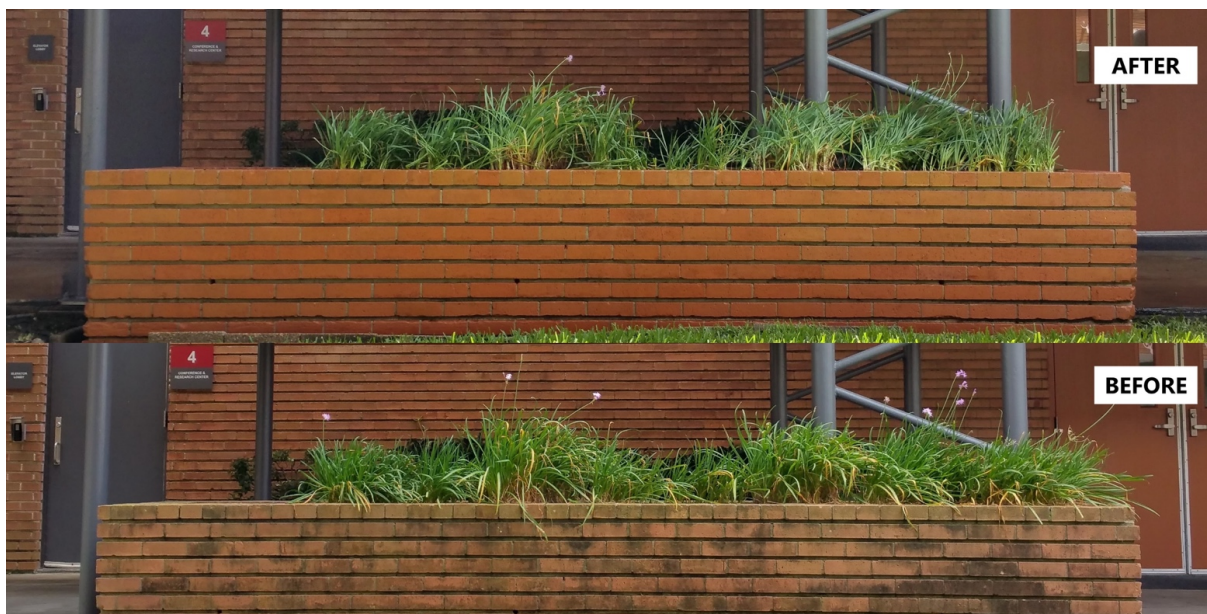
**Figure 4:** Damaged brickwork through years of neglect (lower image) and the wall cleaned and sealed for over 5 years with no delamination (upper

image). The location is the former Schlumberger HQ in downtown Houston off Highway 45. All buildings from 1–5 were treated with sealant to protect against environmental effects.

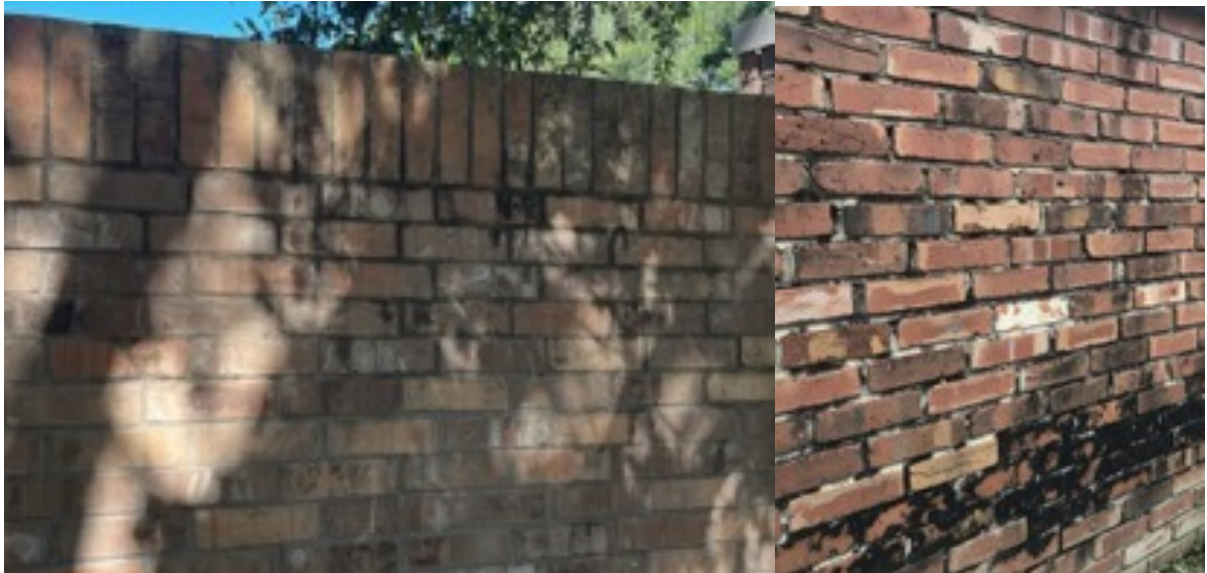
**Figure 6:** Degradation of walls through organic matter such as bacteria, lichen, mold, and mildew. Mold and mildew on brick walls at New Territory, Sugarland in the greater Houston area. This work will last up to 7 years before signs of growth and water damage will appear. The HOA runs the community operations that keeps the environment in such a manner that curb appeal is maintained because the whole appearance of the area is well managed.

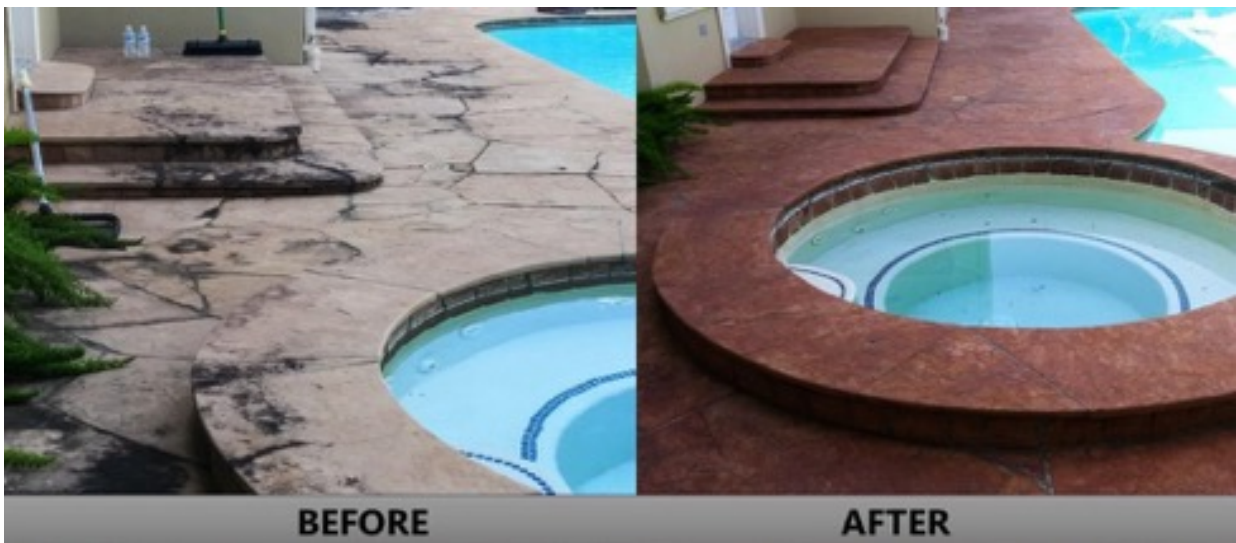
**Figure 7:** First Colony patio area with pool where the tiles are enhanced in color, bringing out the natural look of stone after the oxidation has been removed and the penetrating sealer is used to protect the stone.

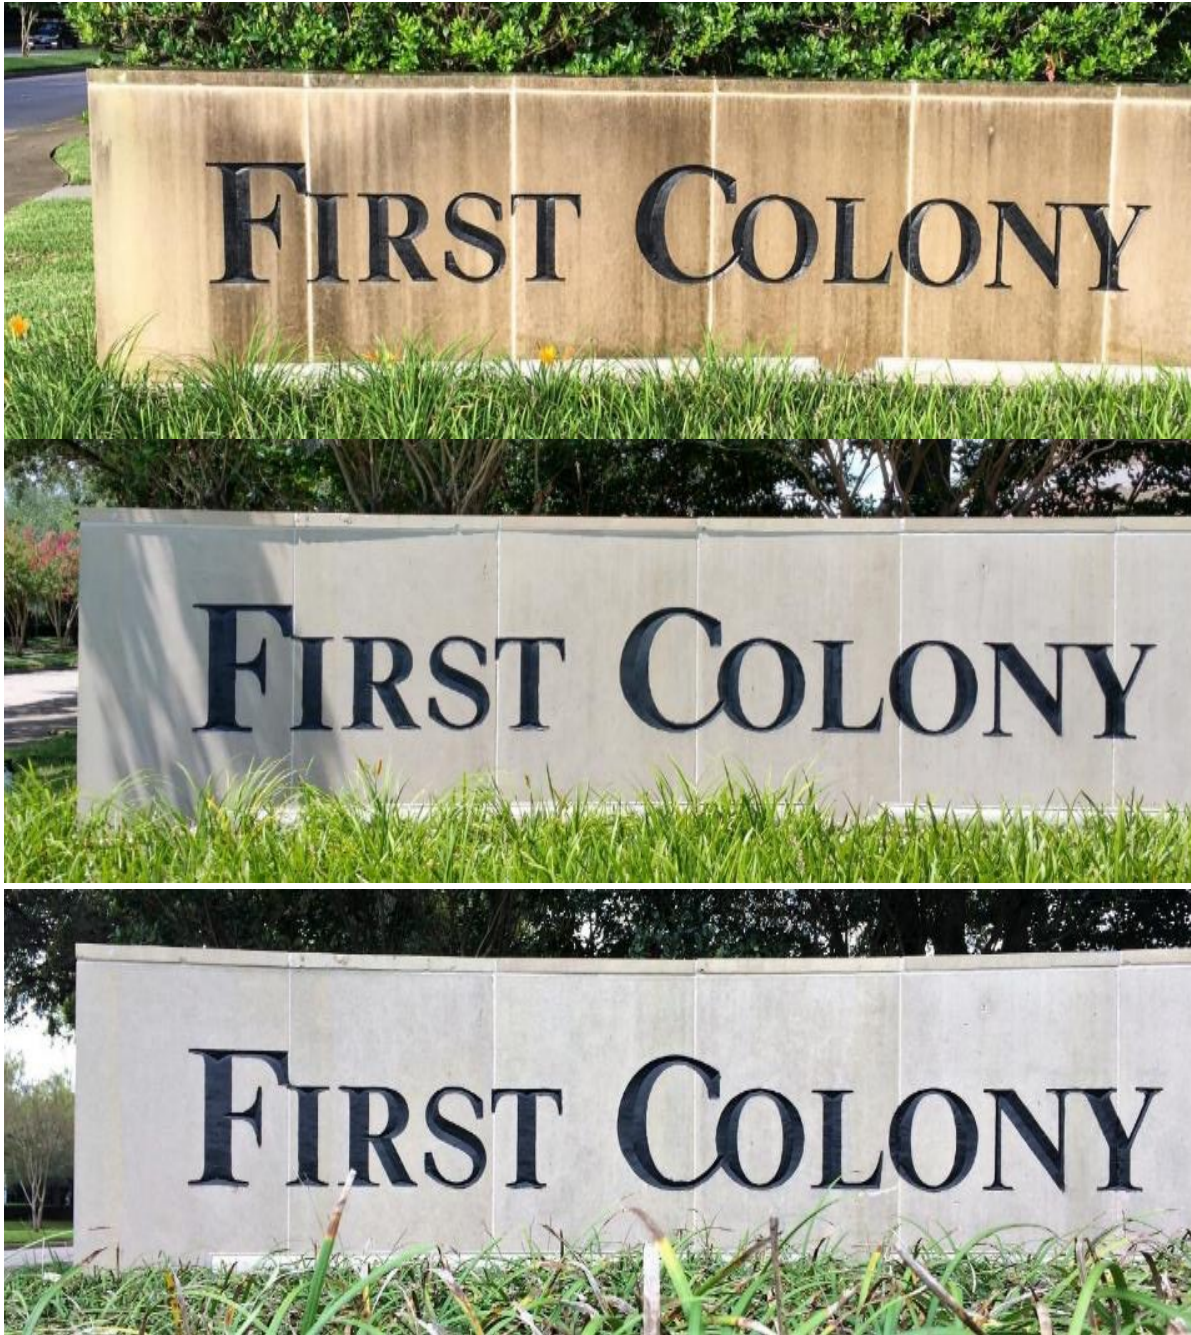
***Figure 8:** These monument signs were being constantly damaged by mold, mildew, water degradation, and constant pressure washing. Treatment with a penetrating cross-sealing silicon-based coating maintains the properties for up to seven years, 4 to 6 years' improvement on current offerings from old paint companies.*

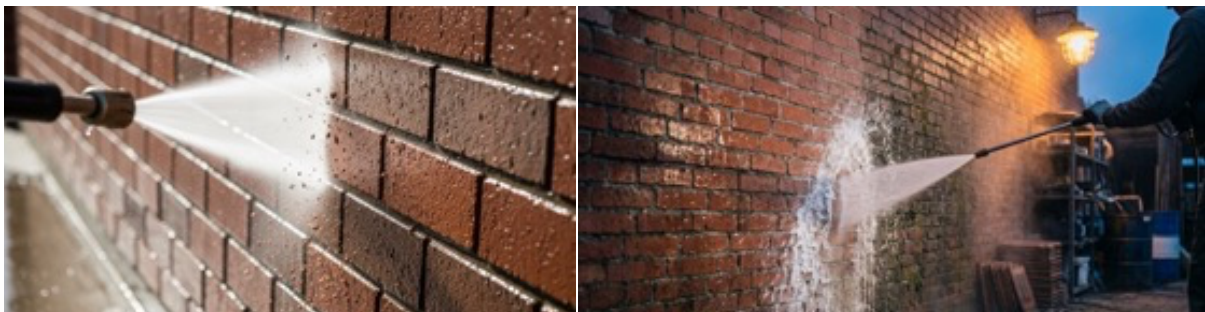
**Figure 9:** To clean red brick safely, use 500 to 1,500 PSI (pounds per square inch) with a wide-angle nozzle (25°–40°), ensuring the tip stays at least 12 inches from the surface to avoid damaging the mortar. For older or delicate brick, use even lower pressure or a soft-wash method. A pressure washer nozzle is designed to send powerful jets of water to clean surfaces, sometimes with the unintended consequence of damaging inside concrete or brickwork. This uses a nozzle creating cone-shaped sprays for highly directed water into specific areas. The nozzle type can be from almost 0° to as much as 40°, and this will allow different pressure levels striking a surface.

The nozzle of all pressure washers is interchangeable. This means the control of water with a suitable pressure-driven system can be used to clean walls or induce cracking. The plume of the

washer can be seen as a cone that uses internal geometry to deflect the high-pressure stream into a fan or circular cone shape. As the water spreads, the impact pressure decreases, but the coverage area increases.

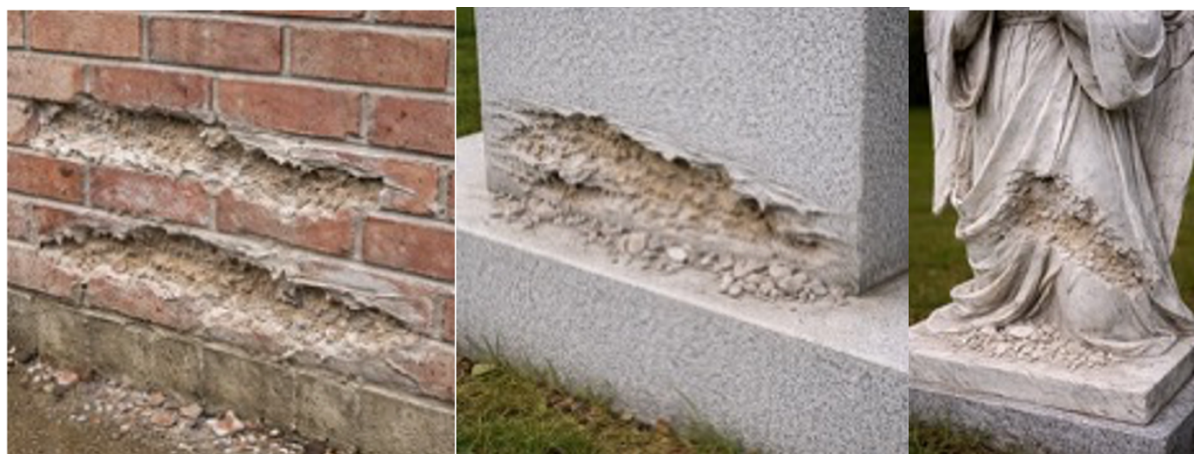
**Figure 10:** *The damage that can be caused by poorly skilled pressure washer technicians.*

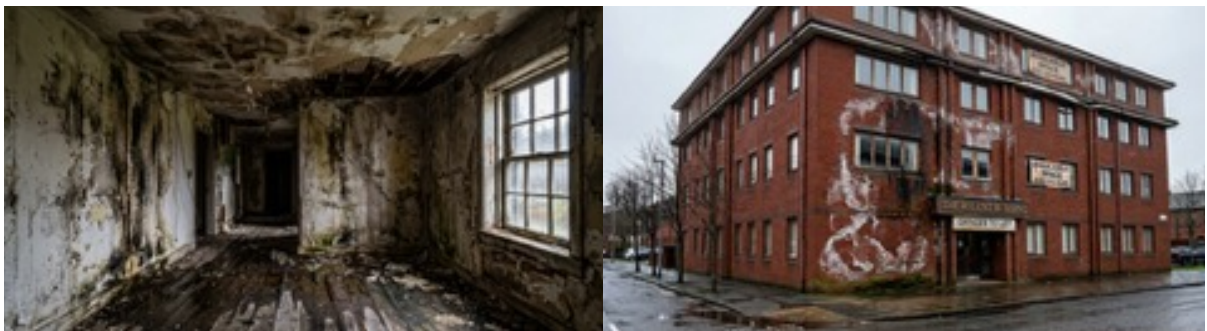
**Figure 12:** This is what will happen both on the interior and exterior of buildings simply caused by water damage, leading to mold and mildew, as well as efflorescence (white color) and physical delamination of the walls.

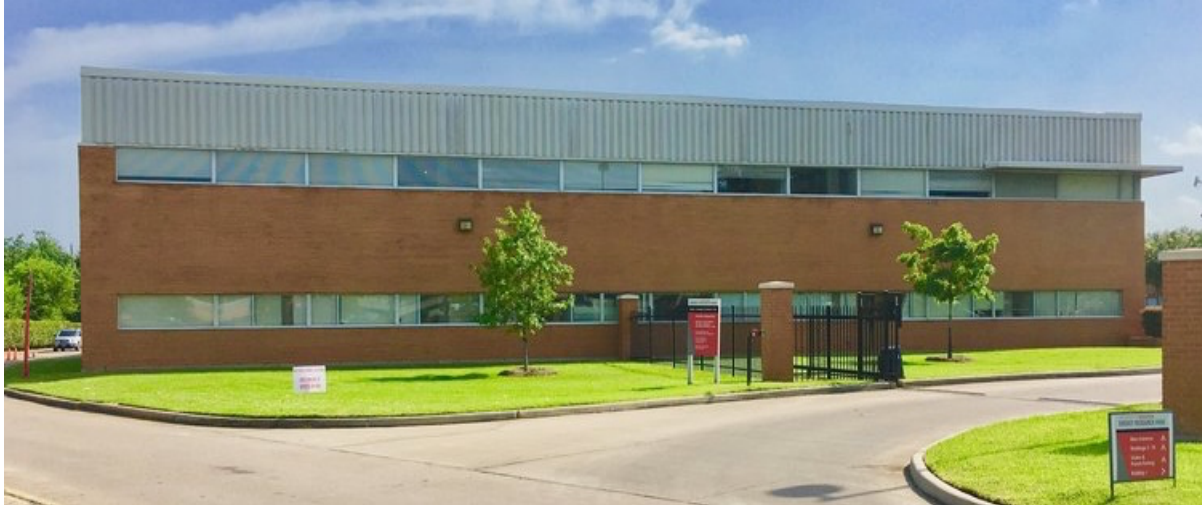
**Figure 13:** Building 2 at the Technology Bridge at the University of Houston after 7 years of exposure to freeze (20°F) to heat (105°F) with humidity levels of >95%, surviving 2 hurricanes.

These buildings are part of the University of Houston, where it has been found that protection has been provided for 7 years. These walls were built in the 1970s and 1980s where waterproof coursing was not part of the construction. The consequence was that over time water wept from the outside into the building, damaging computers and paper files while causing a rising risk of mold and mildew sickness simply from staying within an interior space. These buildings are not designed for architectural beauty but for functionality; however, going to a clean and fresh space makes a work environment far better for employees while also reducing the risk of delamination. This also occurred on main campus at the University of Houston, where water kept seeping into the inside of the building space and resulted in a multi-million dollar facelift to reduce the risk of water damage.
