# Sol-Gel Coatings Masonry Sealer for PFAS-Replacement Coatings that Reduces Sorptivity, Acid-Induced Degradation, and Internal Steel Corrosion in Masonry Materials

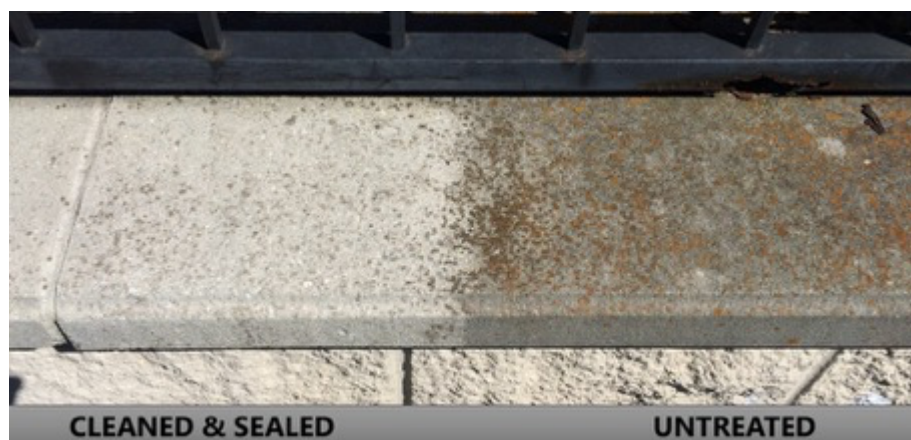
**Figure 1.** Comparison of cleaned and treated masonry (left) and normal untreated stone (right), with the untreated stone showing a prominence of rust from metal railing leaching through the masonry.

To mitigate these effects, hydrophobic surface treatments have been widely utilized to limit water ingress and reduce corrosion-related damage. Figure 1 shows a wall with a metal railing that has been in place for over 8 years in Sugarland, Texas. The metal railing is corroded, causing rust and flakes to leach into the masonry, which in turn accelerates the deterioration of the stonework. Coating the wall after cleaning extends the structure's life by 7 years and protects it by providing a barrier. Traditional coatings have relied heavily on fluorocarbon-based chemistries, such as per- and polyfluoroalkyl substances (PFAS), often referred to as “forever chemicals.” The PFAS group consists of other chemicals used in paints and coatings, such as perfluorooctanoic acid (PFOA) and perfluorooctane sulfonate (PFOS). The PFAS family includes over 12,000 compounds, varying in carbon chain length, partially or fully saturated with fluorine, and bearing polar end groups [6].

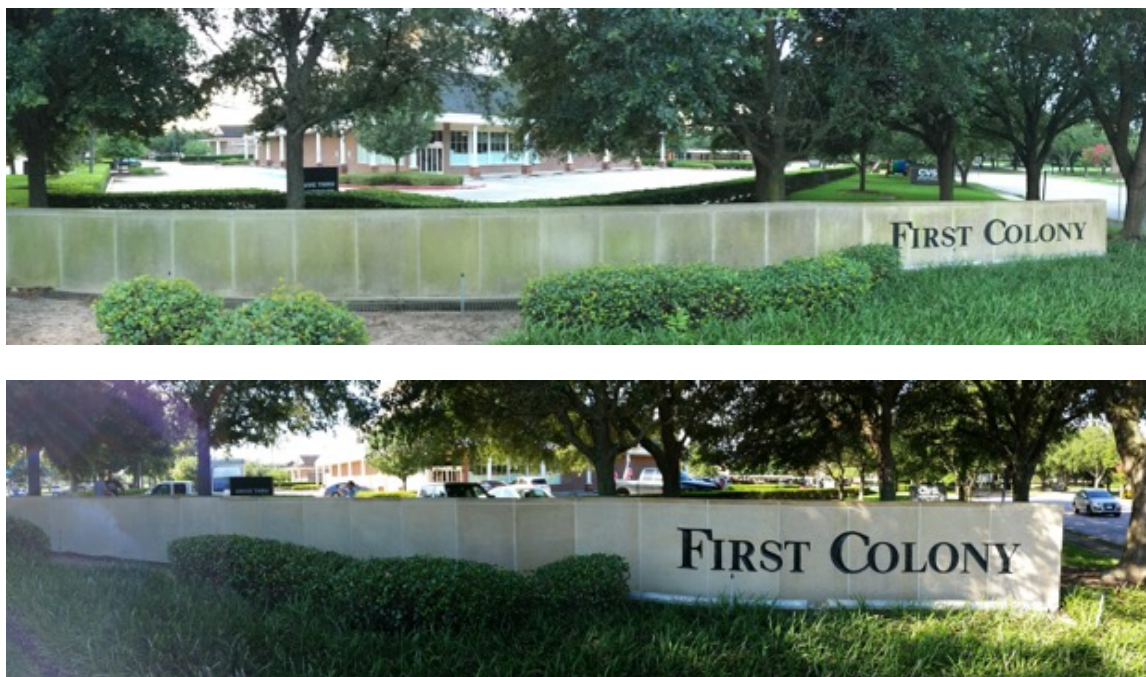
**Figure 5.** Field application of SCHN 158 on a masonry monument signage in First Colony HOA (Sugar Land, Texas).

Figure 5 demonstrates the long-term durability of SCHN 158 under outdoor environmental exposure. The masonry monument previously experienced staining and environmental discoloration, attributed to surrounding vegetation. Prior to coating application,

the structure was cleaned using a low-pressure soft wash treatment (<1500 psi). Following application of SCHN 158, the masonry maintained its structural integrity and visual appearance for over seven years without requiring reapplication (bottom image). Without protective treatment, masonry structures exposed to prolonged moisture experience staining, cracking, delamination, and increased maintenance costs. Field implementation of SCHN 158 has covered more than 100 miles of masonry walls and to over 100 residential communities throughout the Houston area.

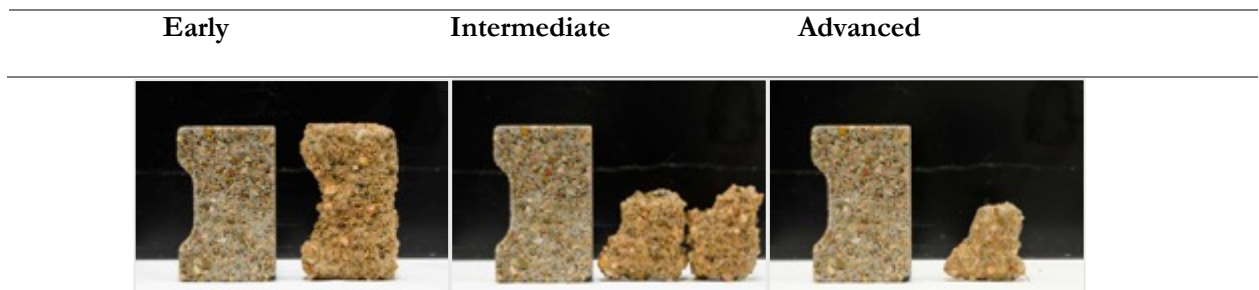
**Figure 6.** SCHN 158-treated samples are represented by the left concrete block. Pristine (untreated) samples are represented by the right concrete block.

The experiment compares SCHN 158 Masonry-treated concrete (left) and pristine (untreated) concrete (right). Both concrete blocks were immersed in 1 M HCl or HNO<sub>3</sub> and photographed over time. This experiment simulated extreme acid exposure.

The pristine concrete samples exhibited progressive deterioration throughout the experiment. In initial stages, the pristine concrete showed surface roughening and material loss. As exposure continued, material loss, increased porosity, and loosening of aggregate particles were observed in the untreated sample. During advanced stage, pristine samples exhibited severe degradation, with the cement having lost its original shape, narrowing in the central region of the specimen, and collapsed along the edges. Severe surface corrosion and exposed aggregate particles were evident in the final images, indicating significant concrete degradation.

In contrast, SCHN 158-treated samples maintained structural integrity throughout the exposure period. Minor visual changes were observed, and the treated sample maintained its original shape and surface texture throughout the experiment.

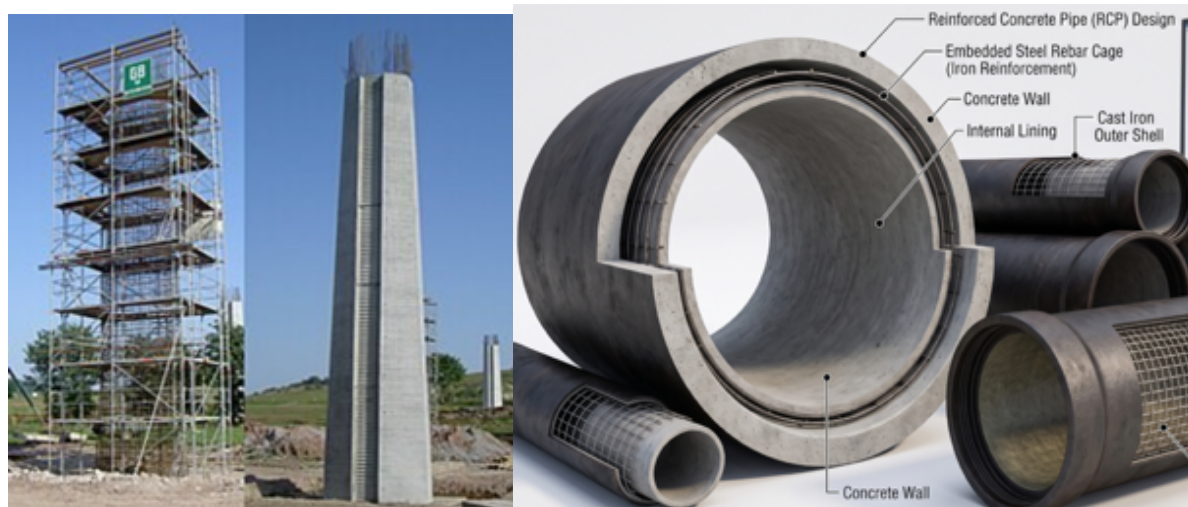
**Figure 13.** a) heavy, reinforced concrete column, seen before and after the concrete has been cast in place around its rebar frame. Photos: Benutzer:Störfix. Combination: Florian.Arnd, CC BY-SA 3.0 <<http://creativecommons.org/licenses/by-sa/3.0/>>, via Wikimedia Commons, b) Structure of reinforced concrete pipe showing the concrete wall, inner lining, and embedded steel reinforcement susceptible to corrosion.
